# Manhole Inspection Summary

Manhole # S25G\_\_039MH

Insp Date: **3/31/08 10:23 AM**

**Location** Address: **13 W Fairmount AV**

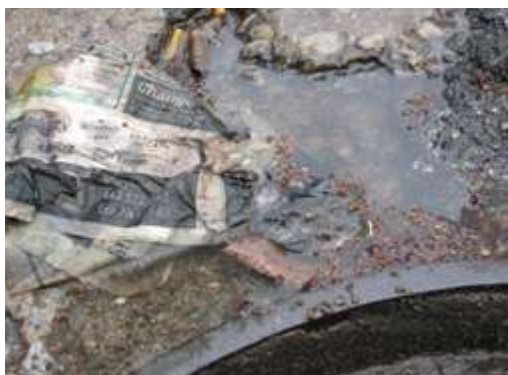
MISCELLANEOUS

Standing water

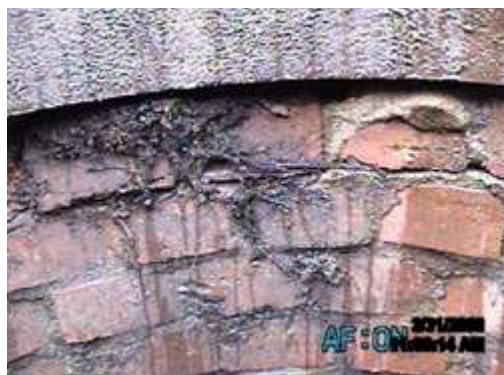
Defect 9

Condition: ☐ Sound ☐ Cracked ☒ **Root Intrusion** ☒ **Loose Brick** ☐ Deteriorated

Infiltration: ☐ None ☐ Joint ☐ Cracks ☒ **Mortar** ☒ **Roots** ☐ Wall

roots in chimney, signs of infiltration

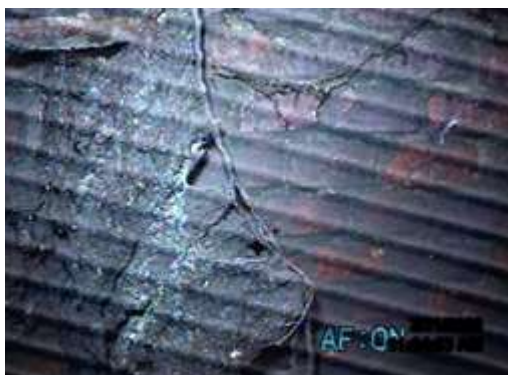
Defect 8

Condition: ☐ Sound ☐ Cracked ☒ **Root Intrusion** ☐ Loose Brick ☒ **Deteriorated**

Infiltration: ☐ None ☐ Joint ☐ Cracks ☐ Mortar ☒ **Roots** ☒ **Wall**

barrel roots and deterioration with infiltration at roots & wall

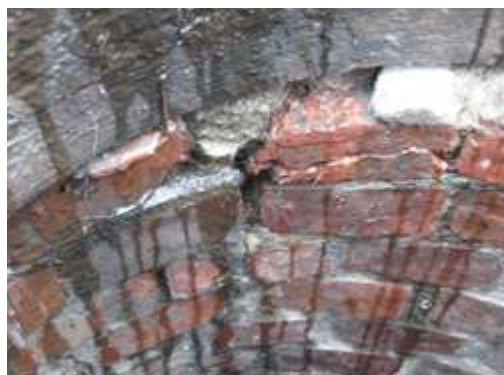
Defect 4

loose bricks, chimney infiltration at mortar

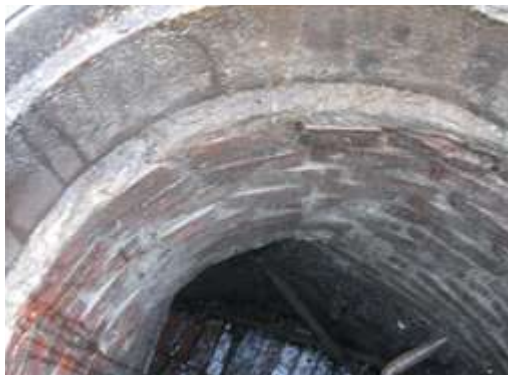
Defect 3

Offset: **2** (in.)

frame offset

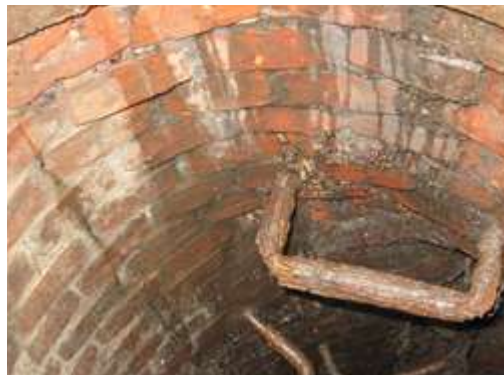
Defect 2

Infiltration: ☐ None ☐ Joint ☐ Cracks ☐ Mortar ☐ Roots ☒ **Wall**

infiltration at corbel wall

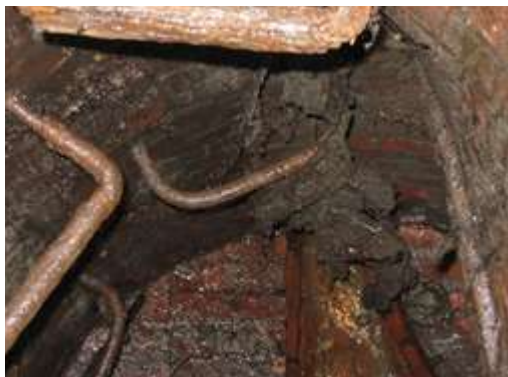
Defect 1

Count: **3** Missing: **0** ☒ **Corroded**

steps corroded
